BERLING DEVELOPMENT PROJECT

Berling Umbilical installation and Seabed intervention 2025; Coral Risk Assessment

Report no.: 2024-4108, Rev. 01

Document no.: 2115916

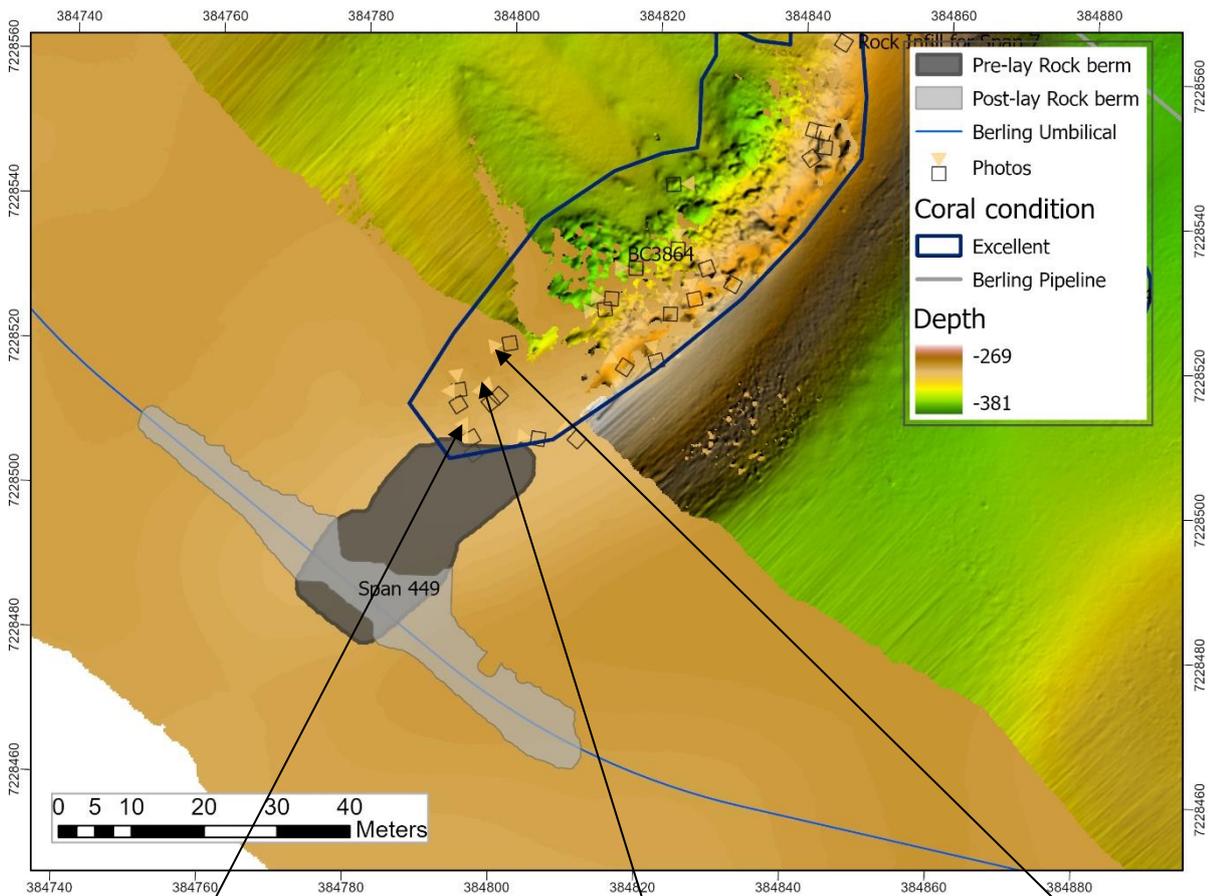
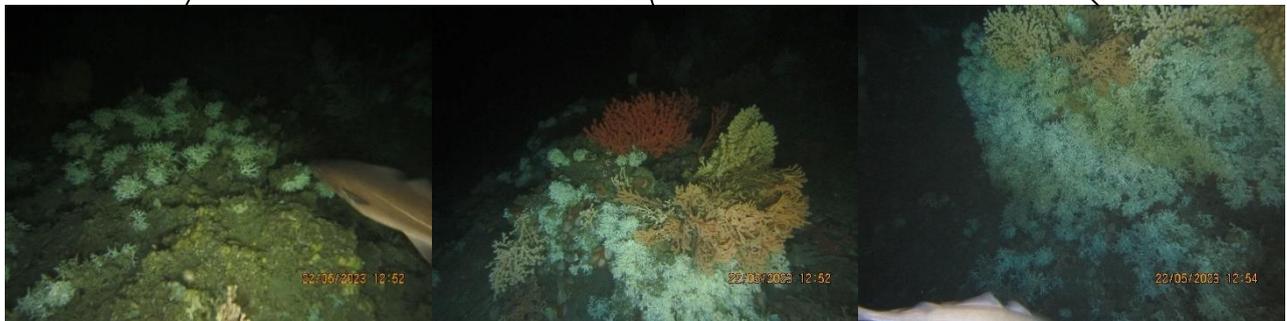
The number of corals at risk within each rock berm is summarized in Table 4-1 and presented in detail in Table 4-2. A total of 20 coral structures have been identified as being at risk at 11 of the rock berms. One Coral structure, BC3864, a coral reef in excellent condition, is expected to be partly covered by rock at Span 449 Figure 4-2. The majority of corals are further away than 25 meters and hence at minor risk. The highest concentration of corals at risk is observed at free span, #298, where 1 coral in excellent condition is located about 7 meters from the rock berm and is in the “severe” risk category. Three corals that have not been visually surveyed are conservatively assessed as being in the “serious” risk category due to their unknown condition. They are all located relatively far away from the planned rock berms (16 to 25 m).

Figure 4-1 The pre and post lay rock berm 449, with neighbouring coral structure BC3864 in excellent condition. Left photo: the outskirts of the coral structure closest to the rock berm, with smaller and less dense reef. Mid photo: Excellent reef and coral garden logged about 10m from the planned rock berm. Right photo: Larger excellent reef structure with coral garden on the top of the reef structure.

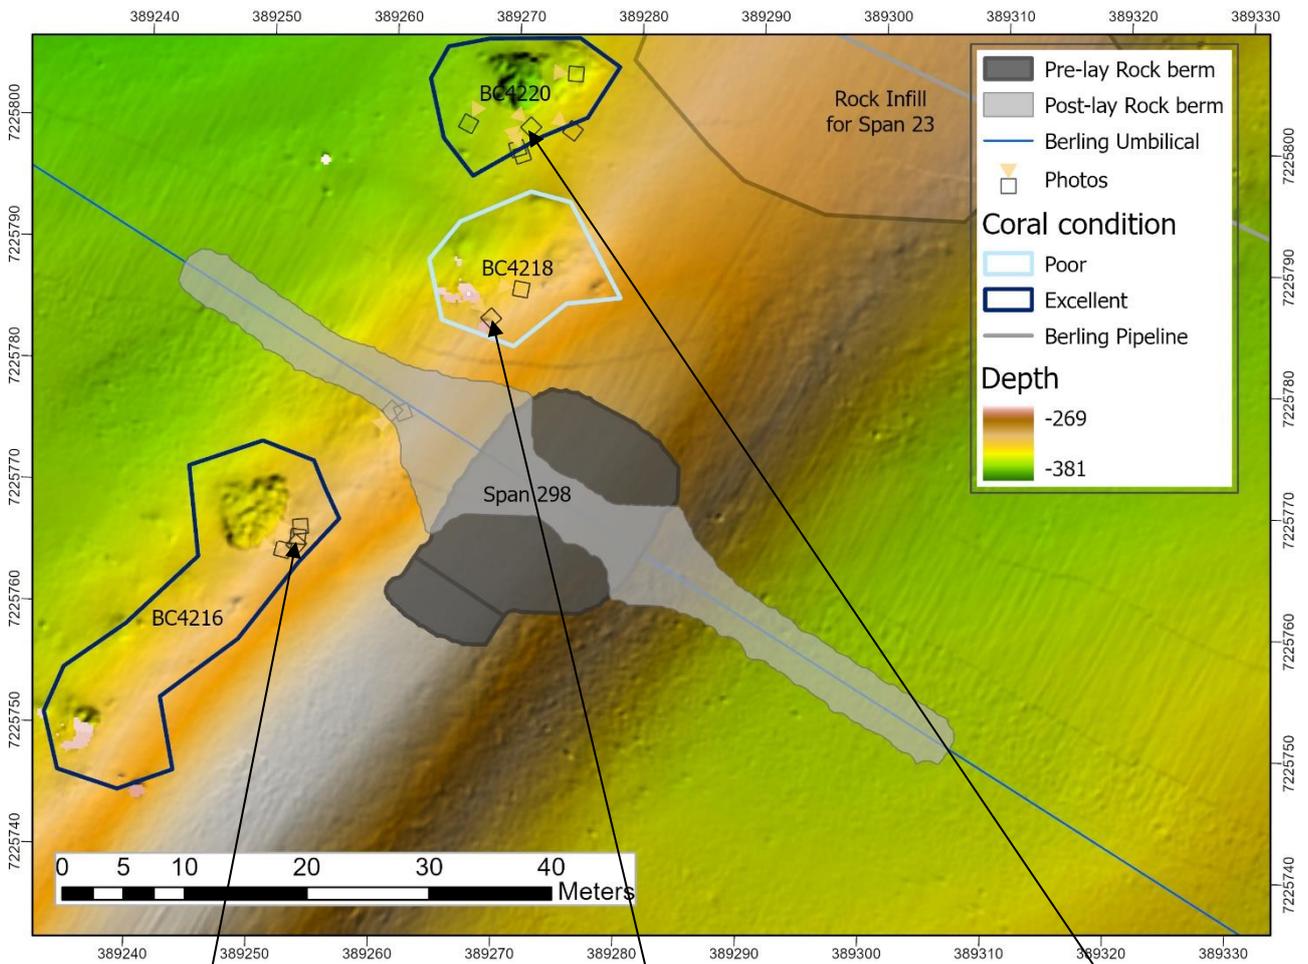
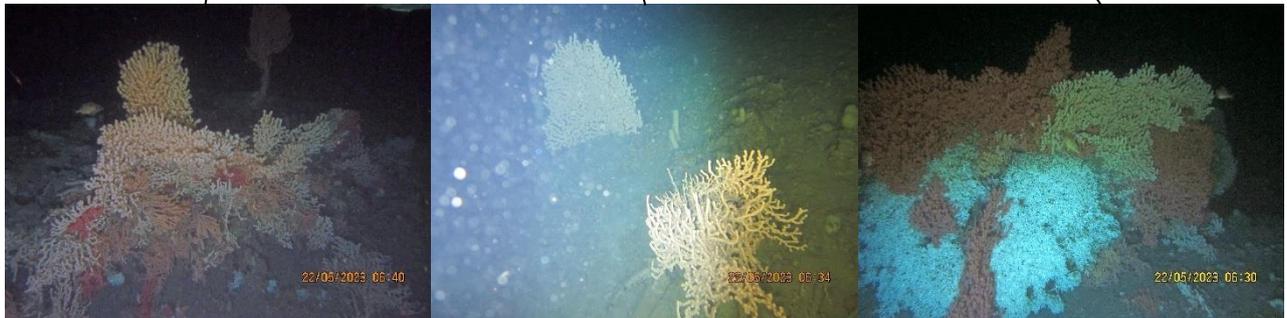
Figure 4-2 The pre and post lay rock berm 298, with neighbouring coral structures. Left photo: Coral BC4216, housing excellent reef and coral gardens. Mid photo: BC4216, dead *D. pertusum* reef with coral garden in poor condition. Right photo: Larger excellent reef structure, B4220 in Minor risk.

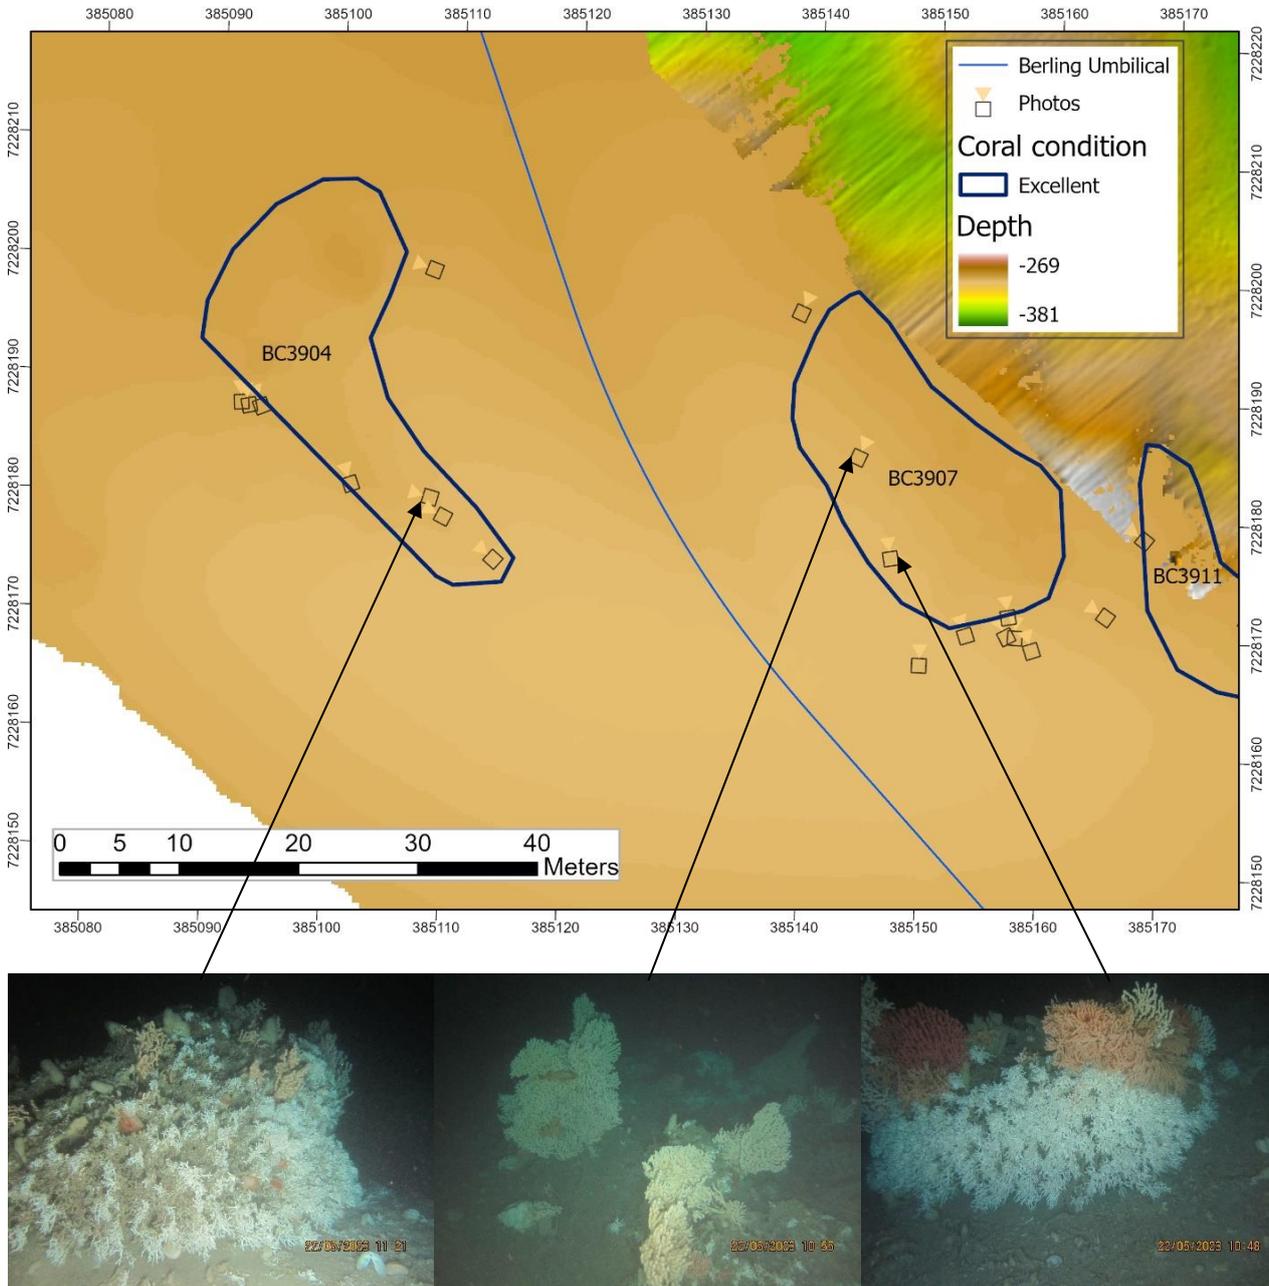
Figure 4-3 Map over area with images from the two corals structures closest to the umbilical; BC3904 and BC3907, in excellent condition.

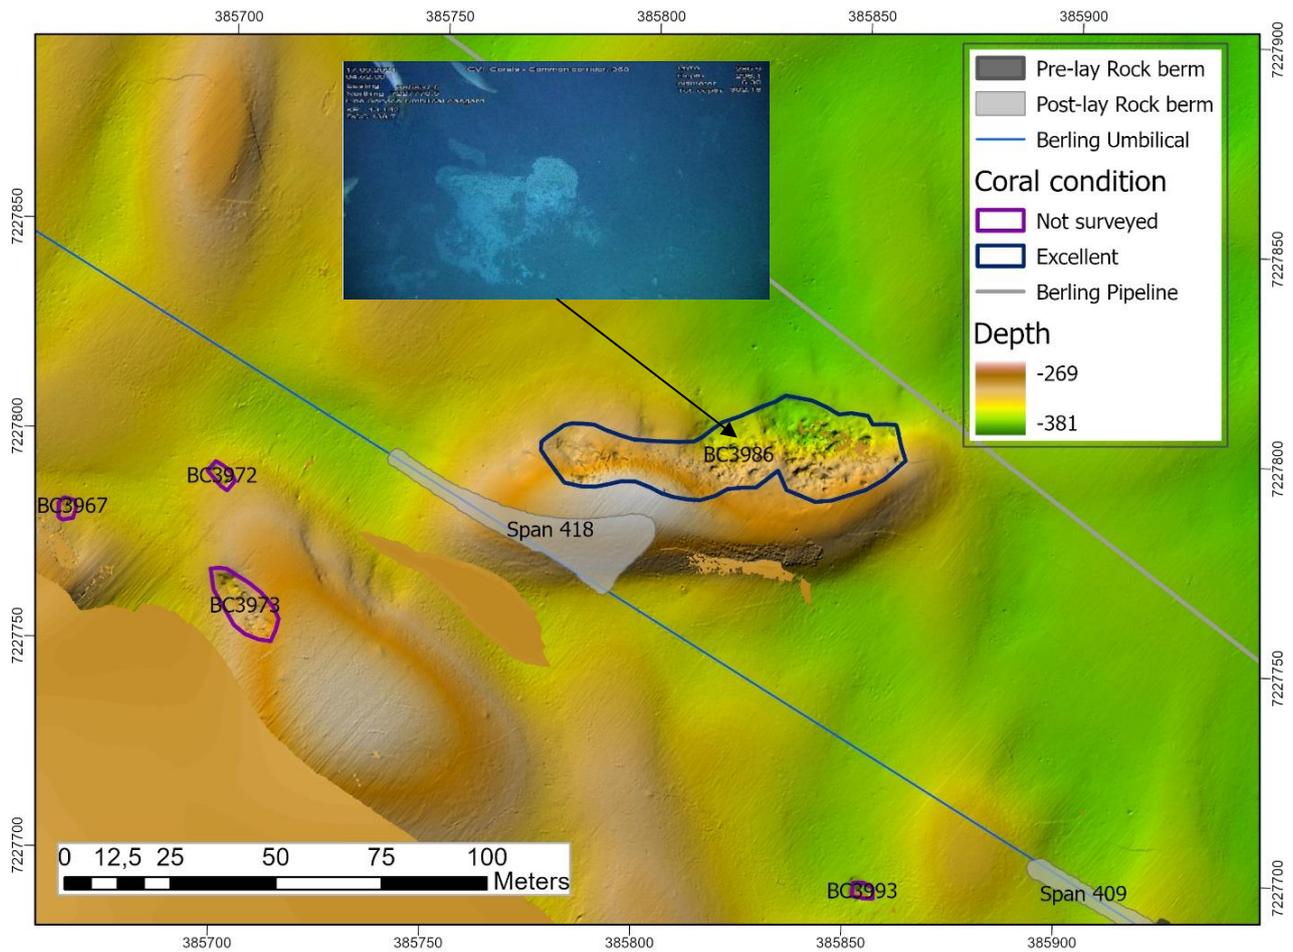
Figure 4-4 Rock post lay Span 418, with closest coral (BC3986) in excellent condition.
