EQ24902 Deimos Coral and Environmental Survey

Equinor 2024 LCV Campaign
Call off Number: 4504326923

27 November 2024

Issued for Use

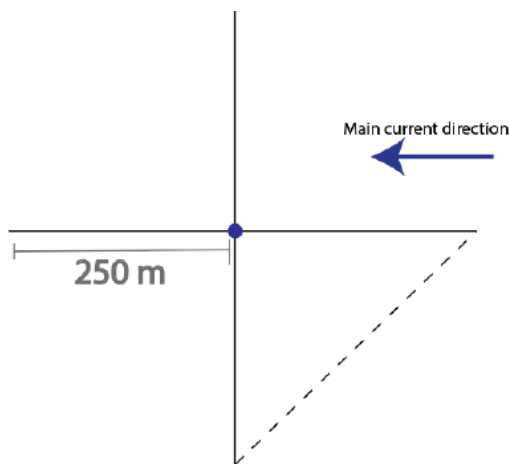
Figure 2-1 A “bow-tie” pattern was run for visual mapping around the wells.

Visual survey was to be carried out at the well location with a “bow-tie” survey pattern. The seabed was to be recorded and logged up to 250 metres from centre location in four directions, where two should be in parallel with and two perpendicular to the main current direction given in the fields or nearby fields Design Basis by Equinor. In total, one location was to be investigated, listed in detail in Table 2-1.

A total of two straight line video transects of 500 metres each crossing over the well location. Run-lines example with “bow-tie” survey pattern and main current direction within Tromsøflaket are shown in Figure 2-1 and Figure 2-2, respectively.

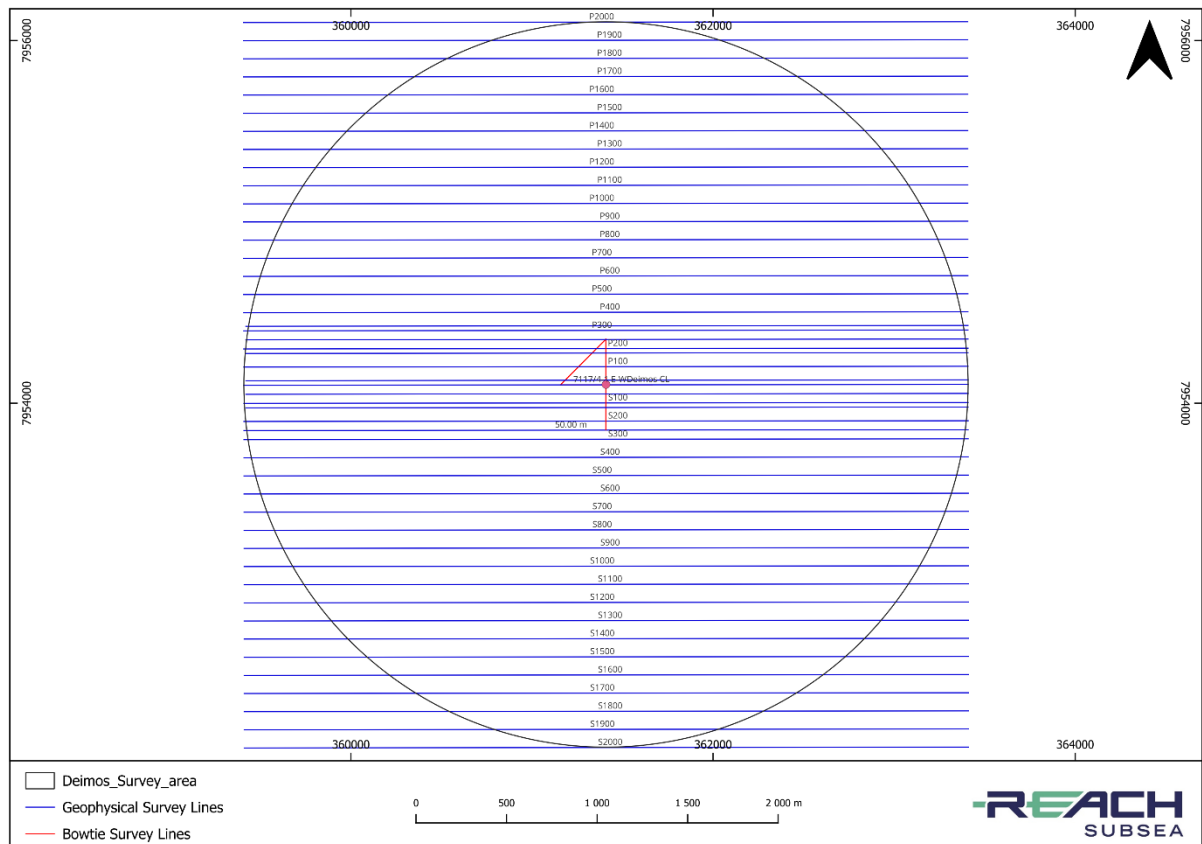
Figure 2-3 Geophysical survey line plan at Deimos

Line plan for high-fly survey area is presented in Figure 2-3. East west orientated lines were used with a line spacing of 100 m and length of 4000 m. In the middle section of the survey area, a line spacing of 75 m is used, to ensure full data density.

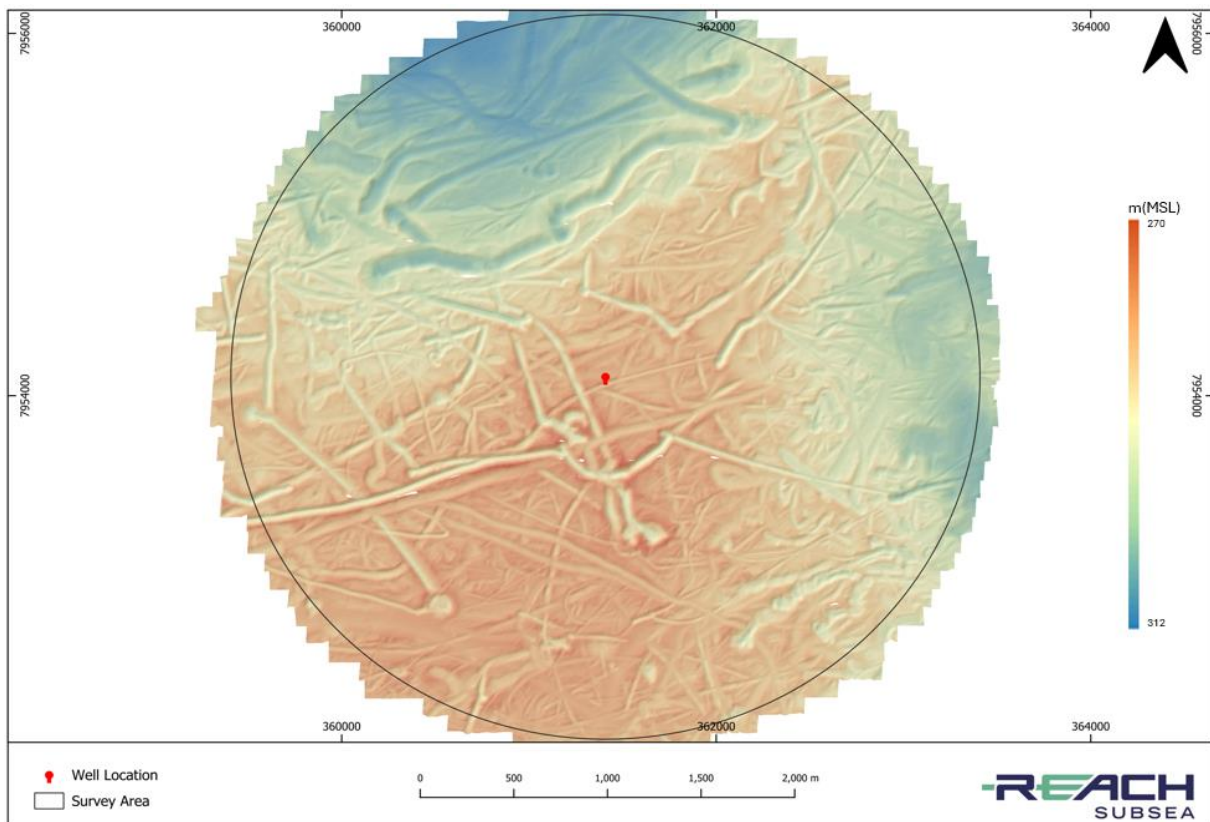
Figure 3-1 Deimos Coral and Environmental Survey - Bathymetric overview

The MBES data over Deimos survey area was of high quality allowing a DTM of 0.5 m grid cell size. The seabed topography was very irregular this was due to shallow iceberg plough marks which were present across the entire survey area. A minimum water depth was observed 272.76 m located 480 m south of the proposed well centre. The maximum water depth was observed 310.23 m in the northeast part of the site. An overview of the bathymetric data is shown Figure 3-1.

The MBES data was of good quality during the survey. The 0.5 m cell size resolution DTM was achieved except for a few acoustic shadows in areas of high topographic relief.

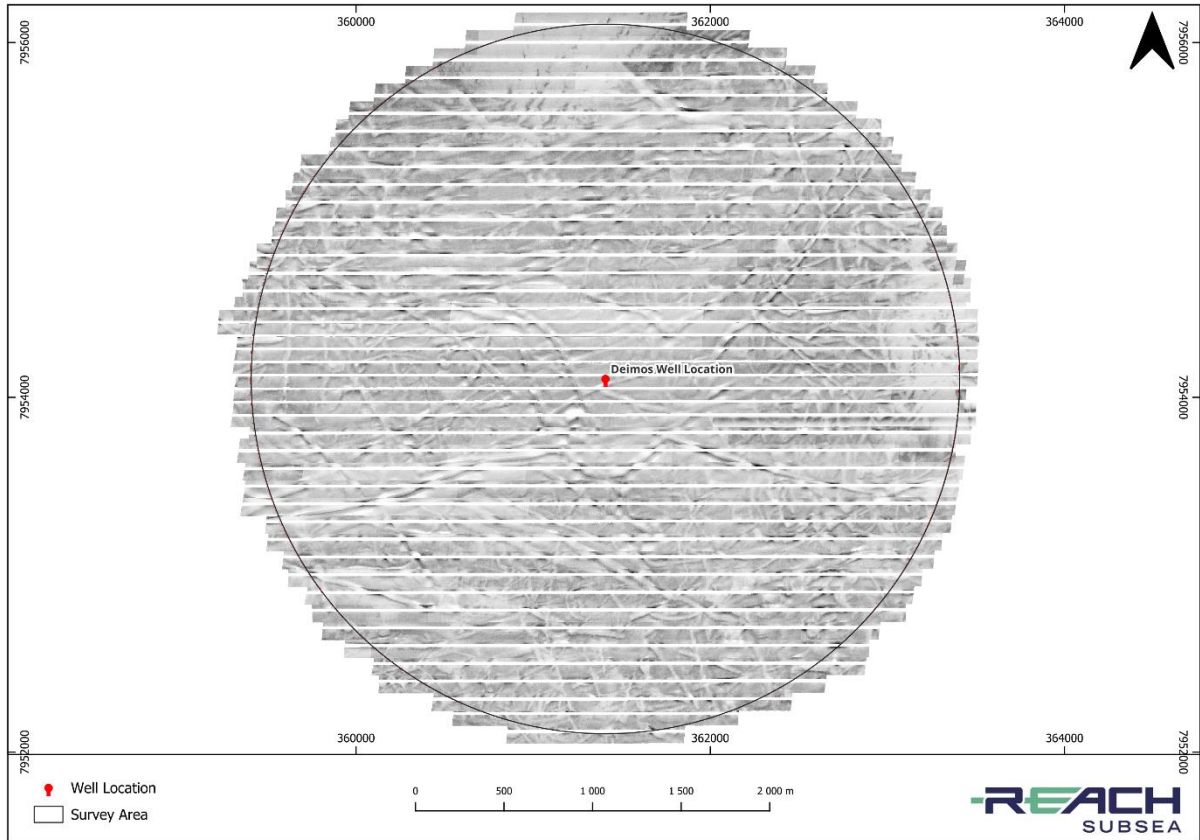
Figure 3-2 Sidescan Sonar overview

The seabed topography of the site is mainly characterised by undulating plough marks, Figure 3-2, and this in turn influences the sonar reflectivity. In general, linear areas of high sonar reflectivity associated with the shoulders of iceberg plough marks typically indicate hard coarse sediments. Lower sonar reflectivity prevalent in the troughs of iceberg plough marks is interpreted as an infill of soft fine sediments.

The sidescan sonar data was of very good quality and fit for purpose throughout the survey. Overall data coverage is good except for some increase noise to signal ratio on the outer ranges of the record.

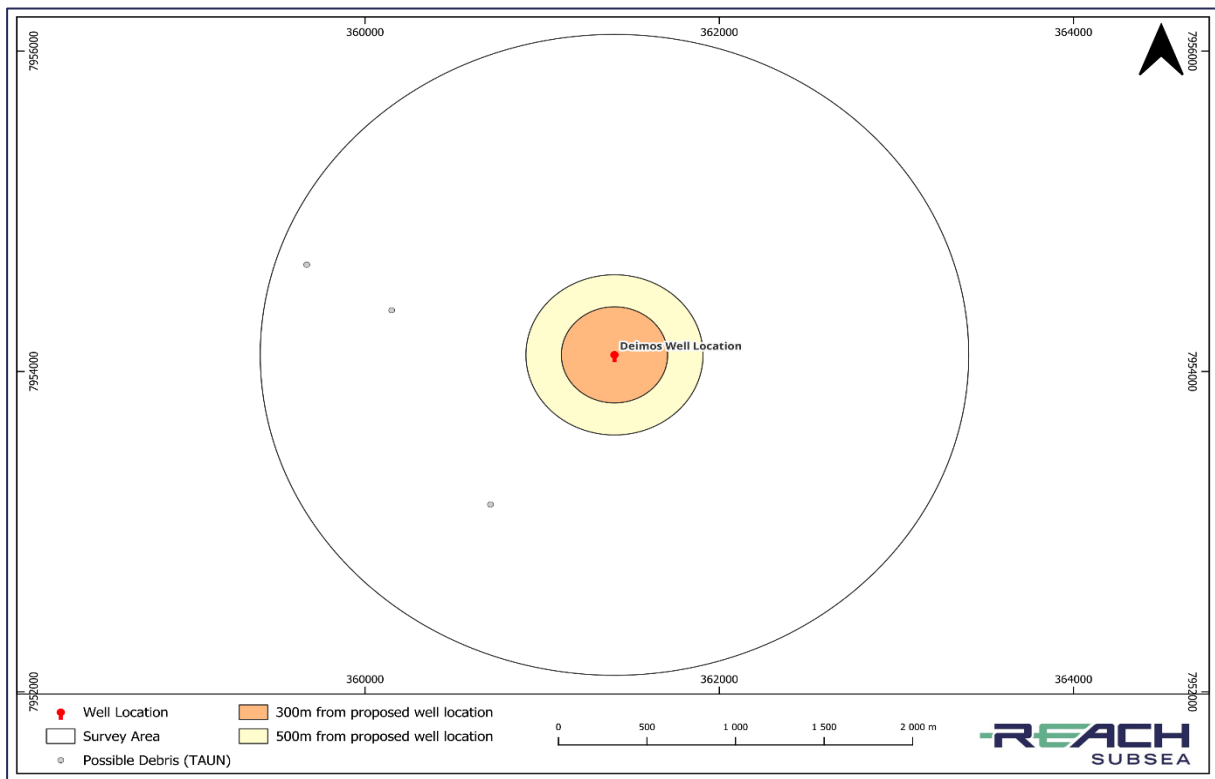
Figure 3-3 Distribution of possible debris (TAUN) in relation to proposed well location

A total of three targets were detected using a combination of MBES and SSS data and are listed in Table 3-1 and presented in Figure 3-3. These three targets were all interpreted as possible debris, no possible coral reef areas were identified.

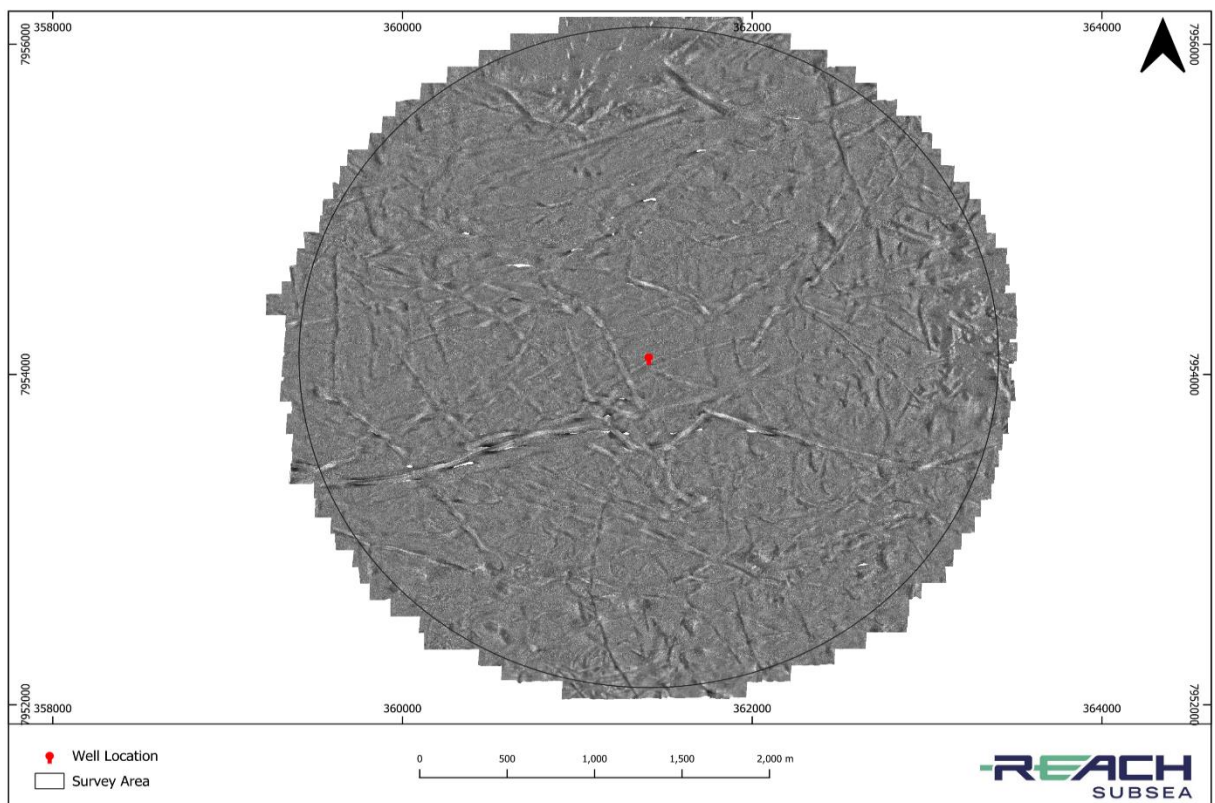
Figure 3-4 Backscatter Data Overview

The backscatter data was processed from the MBES Sensor and is presented on a line-by-line basis. Figure 3-4 provides an overview of the acquired backscatter data.

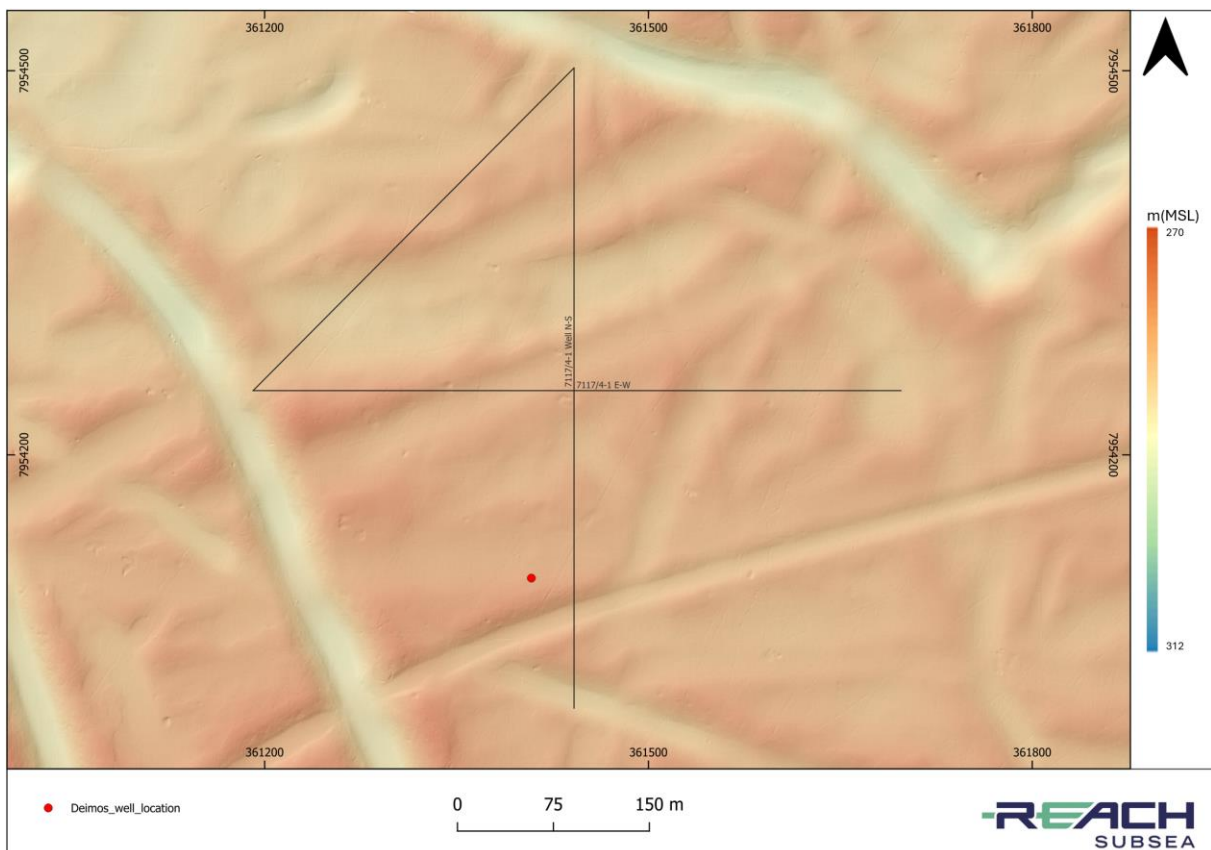
Figure 3-5 Bathymetric overview of Deimos Well Location

One bow-tie was completed, at the proposed Deimos Well Location. An Overview MBES images of each proposed well location are presented in, Figure 3-5. Video image examples are presented in Figure 3-6.

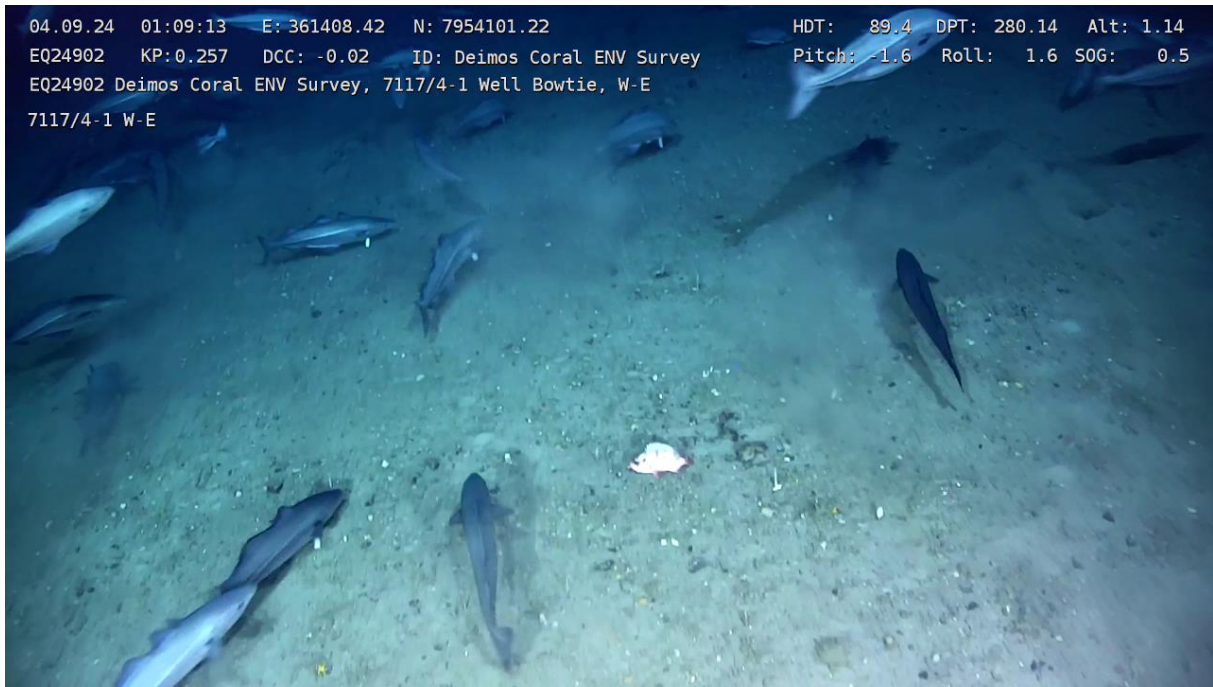
Figure 3-6 HD Camera image at bow-tie location 7117/4-1 Deimos

To comply with the specified requirements of minimum one image every 30 metres, an image was extracted every 12-15 seconds from the camera feed. This selection process ensured a consistent sampling rate and provided a manageable dataset for analysis.

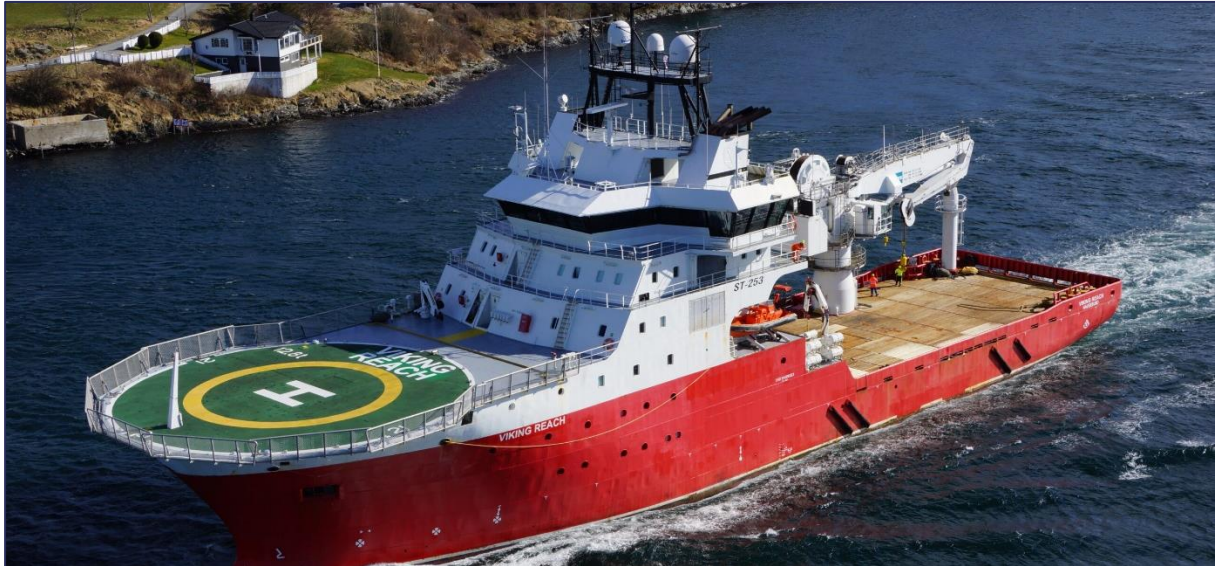
Figure 5-1 M/V Viking Reach

Viking Reach is a multifunctional DP2 subsea vessel from Eidesvik. The vessel was built in 2009 and holds a high standard of both onboard equipment and accommodation/office facilities. The vessel is equipped with a 70-tonne active heave compensated crane on the 625 m² large aft deck.
